DEPARTMENT OF TRANSPORTATION

Contract #: 04-0120F4Cty: SF/ALA Rte: 80 PM: 13.2/13.9File #: 69.28**WELDING INSPECTION REPORT****Resident Engineer:**Siegenthaler, Peter**Address:** 333 Burma Road**City:** Oakland, CA 94607**Report No:** WIR-024723**Date Inspected:** 26-Jun-2011**Project Name:** SAS Superstructure**OSM Arrival Time:** 700**Prime Contractor:** American Bridge/Fluor Enterprises, a JV**OSM Departure Time:** 1900**Contractor:** Zhenhua Port Machinery Company, Ltd (ZPMC), Changxing Island **Location:** Shanghai, China

Orthotropic Box Girder (OBG) at Trial Assembly Areas

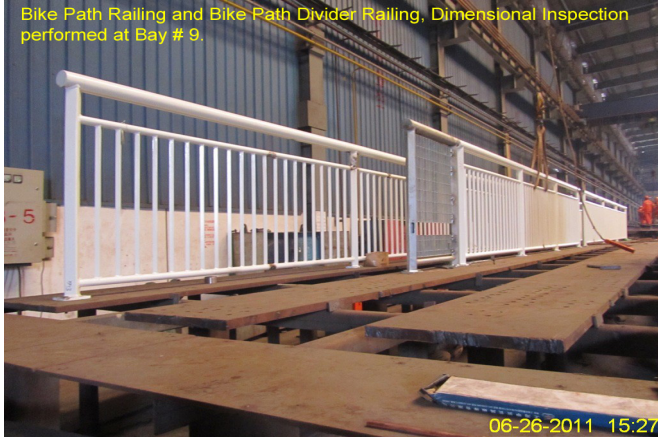
Performed the Dimensional Inspection and observed results are in general compliance with the tolerances, during the course of inspection ZPMC Mr. Chen Shi Gang and ABF Mr. Liu Cheng were present. Informed the results of Inspection to Caltrans Lead Inspector for further disposition.
